**Air Expendable Current Profiling During  
The OCEAN STORMS Experiment**

Technical Report  
**APL-UW TR 8916**  
February 1990

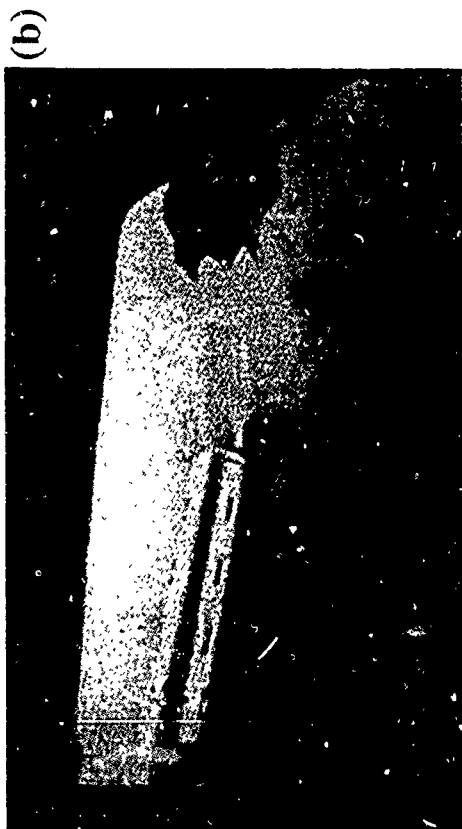
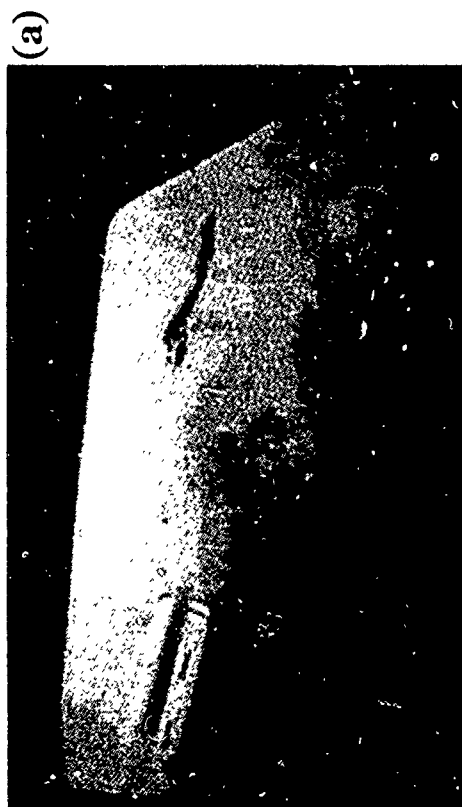
*Figure 20. As in Figure 19. Note parachute deployment.*
